Air separation industry varnish removal and oil pollution control

Kunshan WSD Environment Protection Equipment Co.,Ltd.

WSD - oil pollution control expert

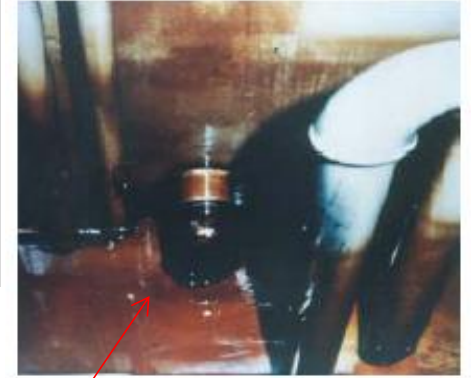
varnish on bearing bush

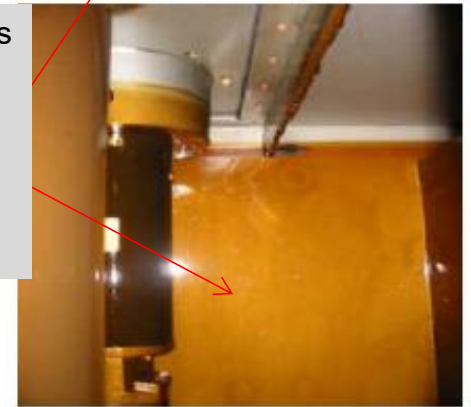
varnish on the tank wall

Initially, the surface is gold/tawny, but over time, the accessory is gradually covered with a darker rubbery coating, which eventually becomes a hard, paintlike substance

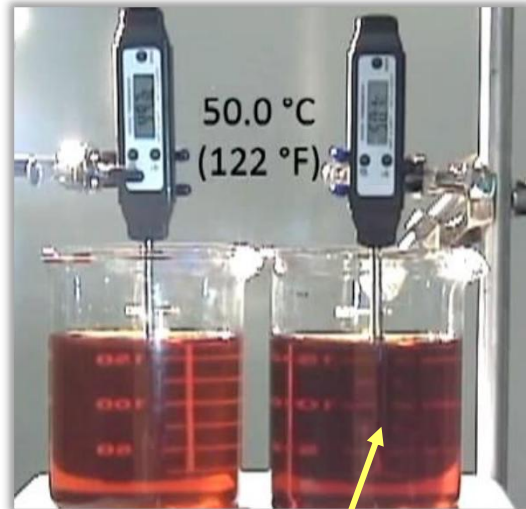
dissolved state

When the temperature is high, the ability of the varnish to dissolve increases with the rise of the oil temperature, and the varnish exists in the oil in a dissolved state, so the oil is transparent

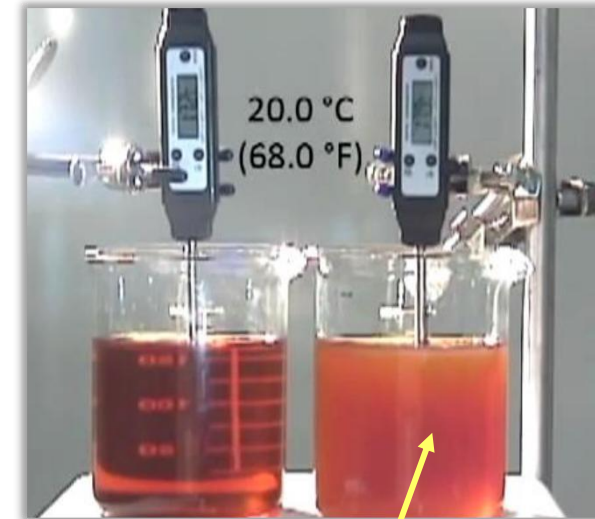
it becomes suspended after precipitation

When the temperature decreases, varnish dissolve ability becomes worse with the decrease of the oil temperature, and the varnish exists in the oil in the precipitation state, so the oil becomes turbid

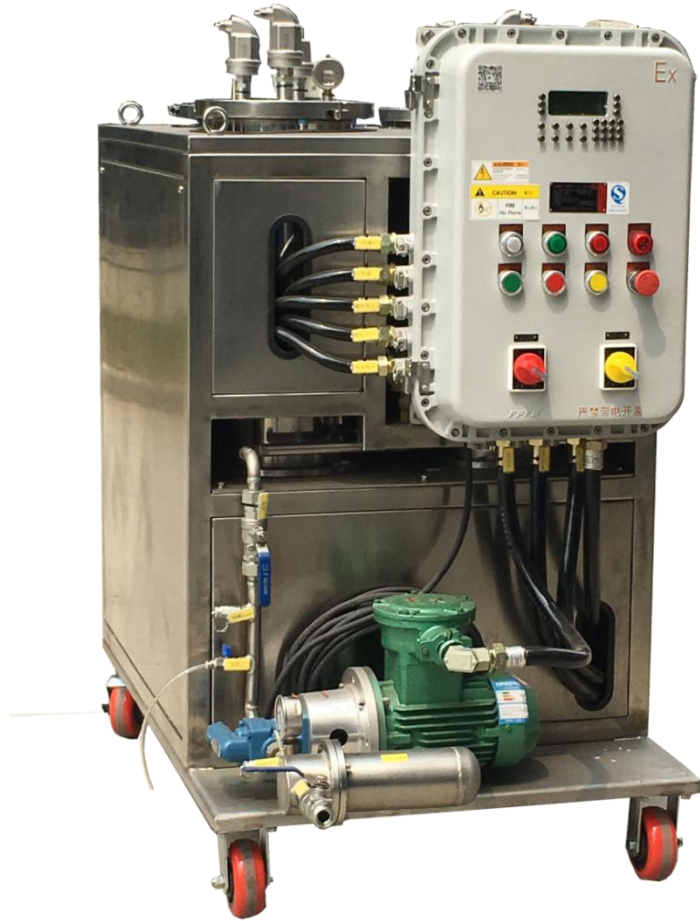
▲ explosion-proof

Pattern	WVD™ -II
Length	1005 mm
Width	771 mm
Height	1314mm
Weight	300 kg
Power	380 V, 50Hz, 3 phase
Flow rate	20L/min
CE certificate/explosion-proof certification	Yes
Seal ring	fluororubber
Tank size (depending on the type of oil, pollutants and application)	≤ 80,000 litre
	Fixed or moved
viscosity range	22-100cSt @ 40oC
Better liquid temperature	40 – 70°C

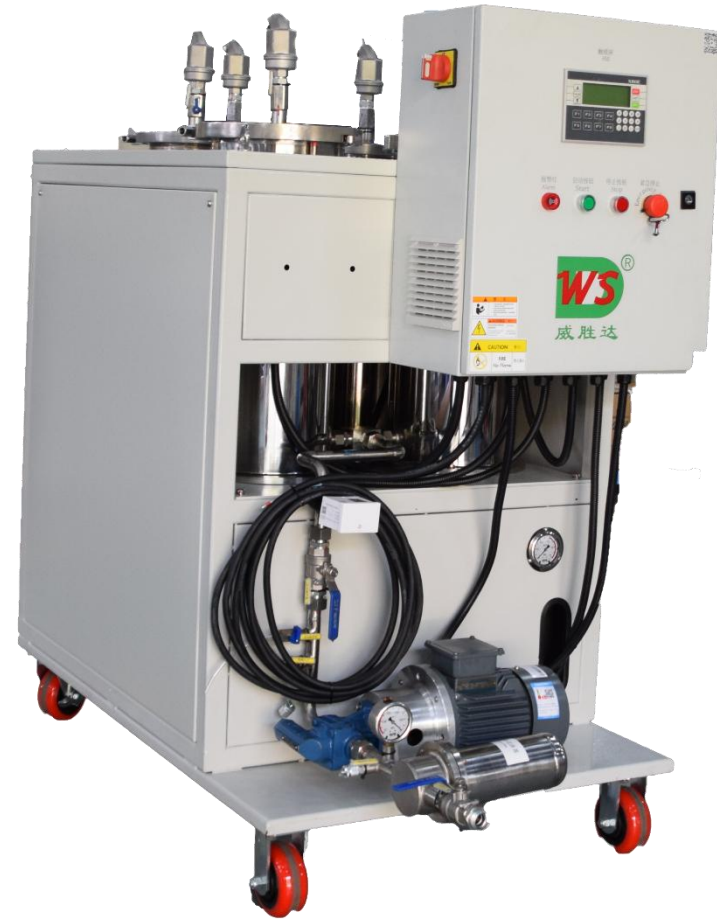
▲ Non explosion-proof

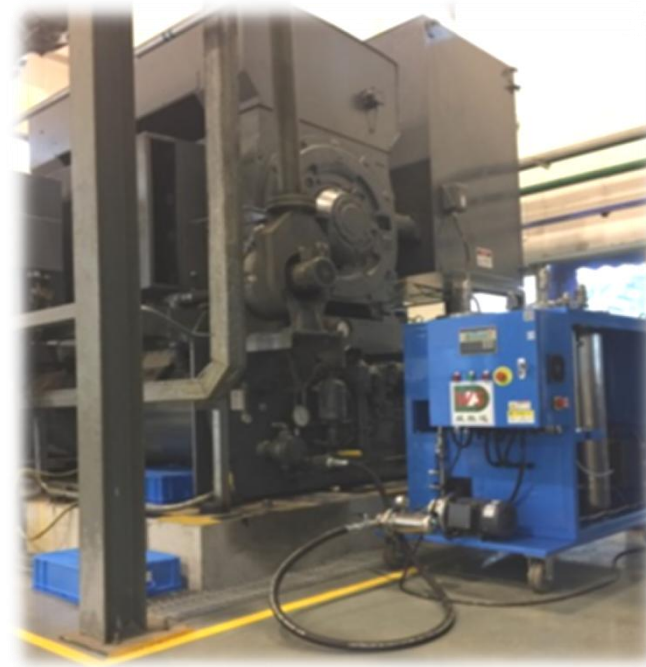
Customer pain point: an air compressor in Suzhou factory caused bearing temperature fluctuation due to varnish, the situation is serious, the unit was forced to stop for maintenance

Device name: Atlas compressor

Tank capacity: 6.5m³

▲ Device installation diagram

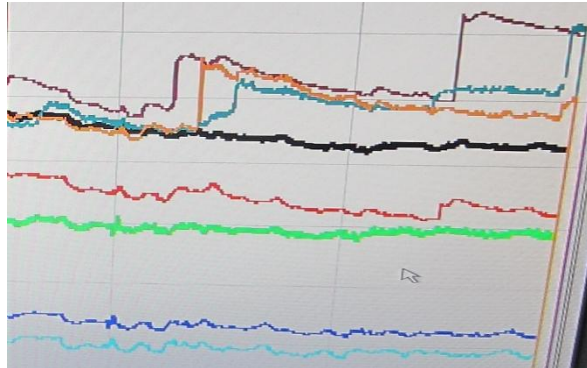
Before purification

MPC:14

Cleanliness NAS1638: 4 level

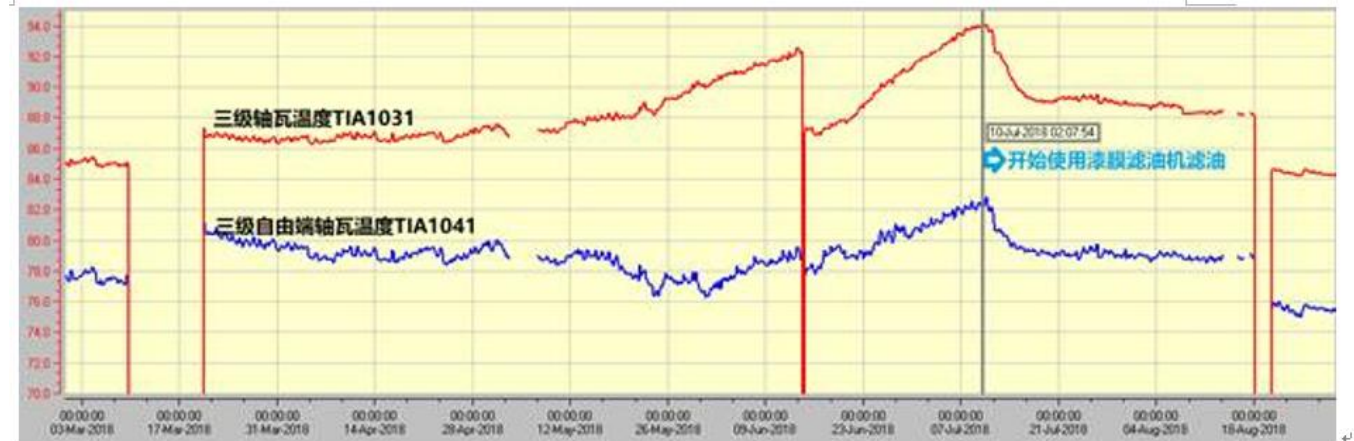
After using our WVD-II varnish removal unit in Suzhou factory, the abnormal phenomenon of bearing temperature trend rising slowly appeared in Ningbo factory. After 30 days of using our WVD-II varnish removal unit, the abnormal phenomenon of bearing temperature was significantly improved

bearing bush temperature trend

Comparison item	Before purification	After purification
Temperature of three grade bearing bush (°C)	94.1	84.2
Temperature of three-stage free end bearing bush (°C)	82.8	75.4
Varnish tendency index MPC	17.7	8.6

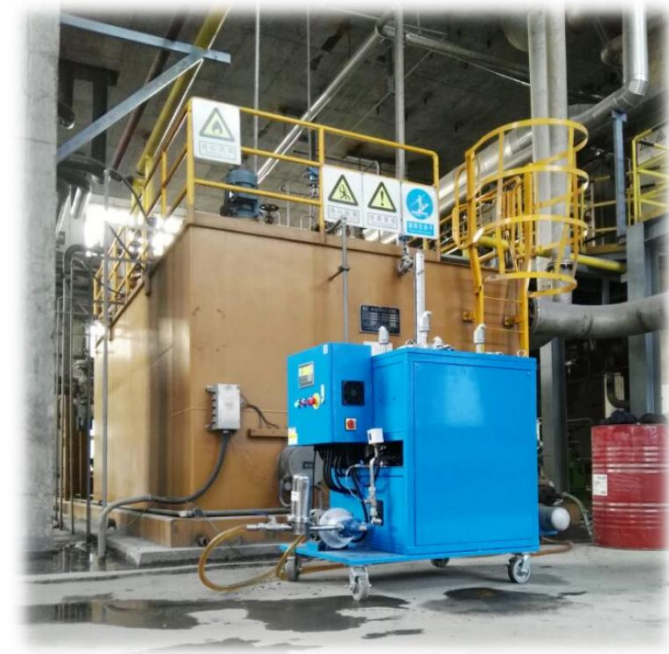
Customer pain points: Customer 43000 large air separation, compressor using MAN turbine unit, thin oil station of about 48 cubic meters, using No. 46 turbine oil; MPC value was 21.2 when tested 36 months after startup, and rose to 24.8 when tested 44 months later, showing an upward trend, and there was varnish accumulation in bearing bush during previous maintenance

▲ Device installation diagram

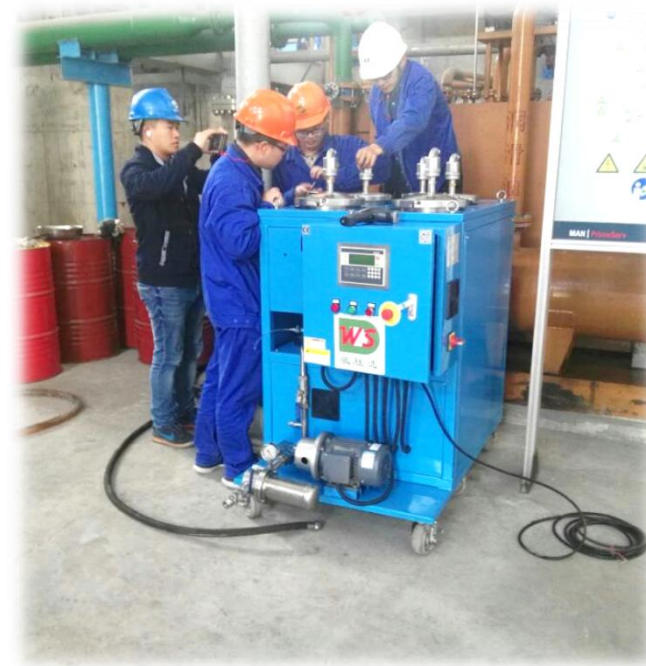
Customer pain point: In September 2017, the bearing temperature of supercharger slowly rose to 92°C, causing the risk of jumping

Device name: 40,000 air separation supercharger

▲ Device installation diagram

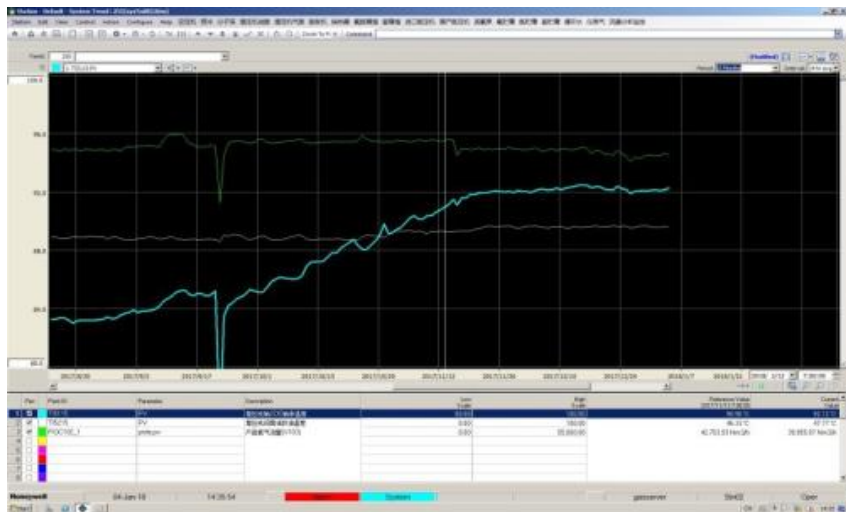
Before purification

In September 2017, the bearing temperature of the supercharger rose slowly
In November 2017, the bearing temperature rose to 92°C

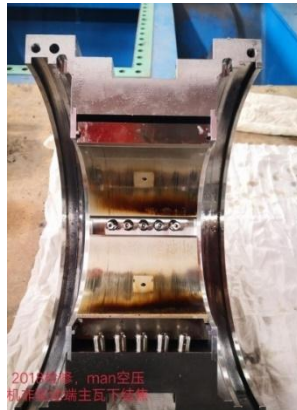
In 2018, the main bearing bush of the non-driving end of MAN air compressor was coking

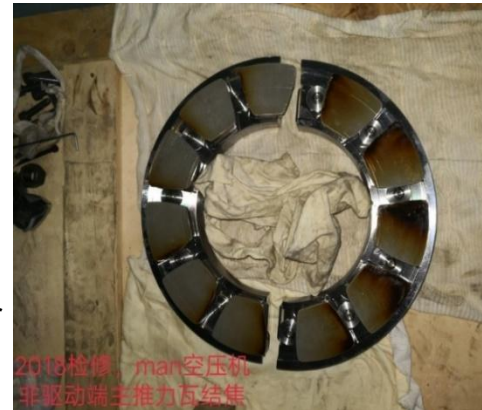
In 2018, the main bearing bush of the non-driving end of the air compressor was coking

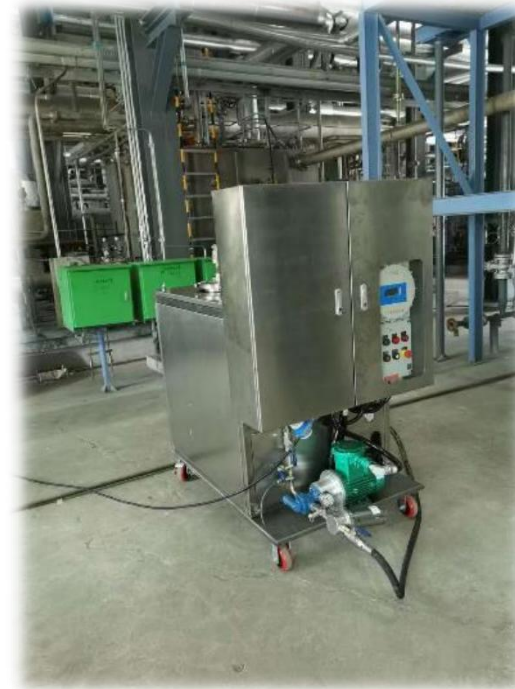
Customer's pain point: The customer's syngas centrifugal unit uses Shell 46# turbine oil. During the maintenance process, it was found that the bearing bush of the unit had varnish carbon accumulation, which often fluctuated abnormally in the normal operation process.

▲ Device installation diagram

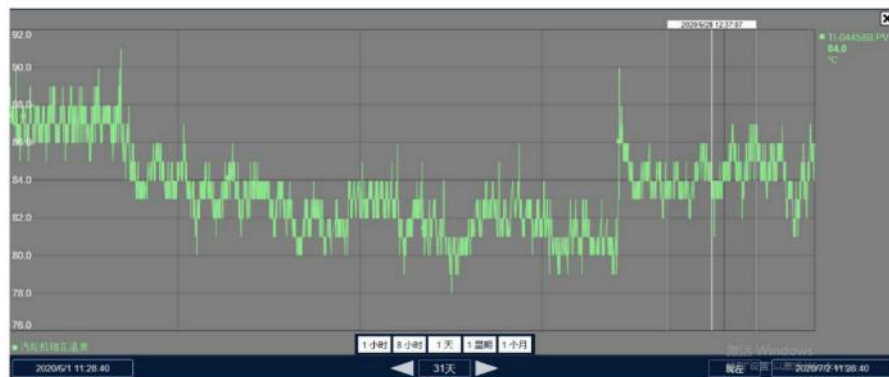
净化前后 T1-04458B PV 温度变化图

31 days after run

Temp from 91°C
to 78°C

6月1日-7月2日温度变化曲线图（最高温 91 度，最低温 78 度）

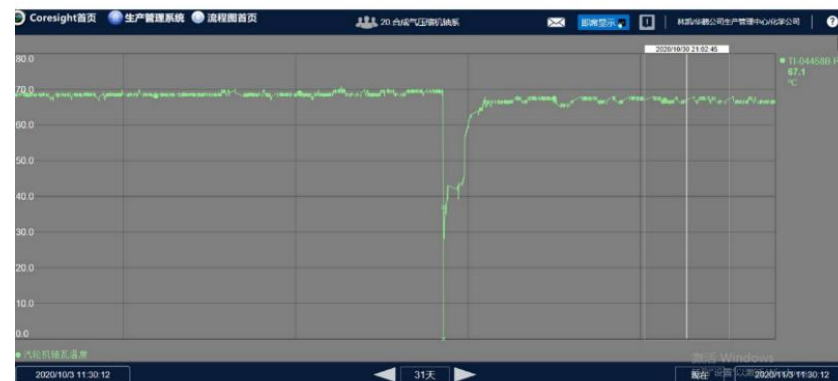
After 4 months continuous run

Temperature stability in 70°C
bottom to 67°C

10月3日-11月3日温度变化曲线图（最高温 70 度，最低温 67 度）

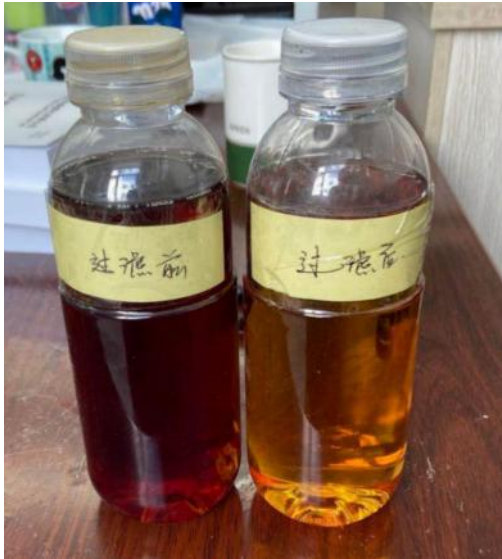
▲ Comparison of oil samples before and after purification

The customer purchased the varnish removal unit from our company in June 2020. The operation of the equipment has achieved good results so far. Within one month, the MPC value decreased from the original 22.4 to 2.5, and the cleanliness level decreased from the original NAS9 to NAS7.

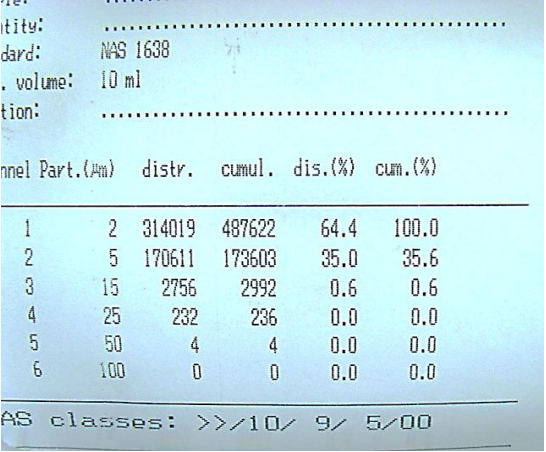
The **aperture of filter** element determines the **filtration accuracy**

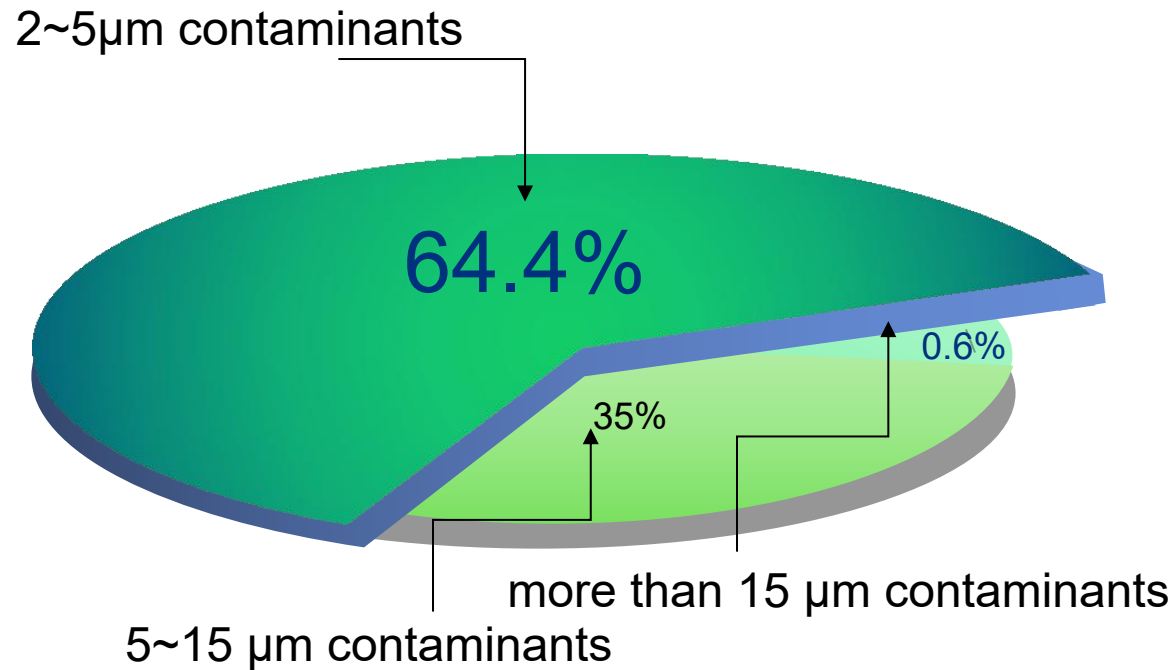
More than 60% of contaminants are less than 5µm in old systems

The release of pollutants monitored by particle counters found that the particles of 2~5 microns and 5~15 microns were the most, accounting for 64.4% and 35% respectively.

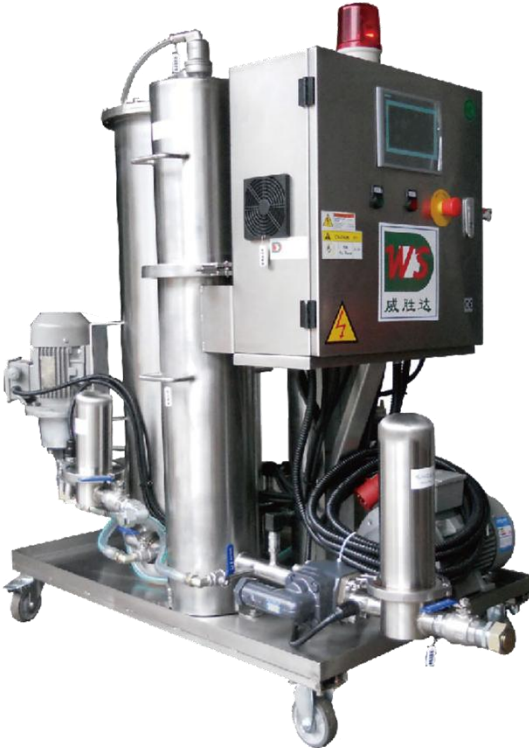
Balanced Charge Purification

The positive and negative electrodes are placed in two paths in the non-conductive fluid to charge and charge the particulate pollutants in the fluid, one is loaded with positive (+) charges, the other is loaded with negative (-) charges, and then the oppositely charged electrodes are charged. The particles are remixed, attract each other and accumulate into agglomerates, and the size becomes larger, so that the small particles that are not easy to filter are easier to be removed by filtration.

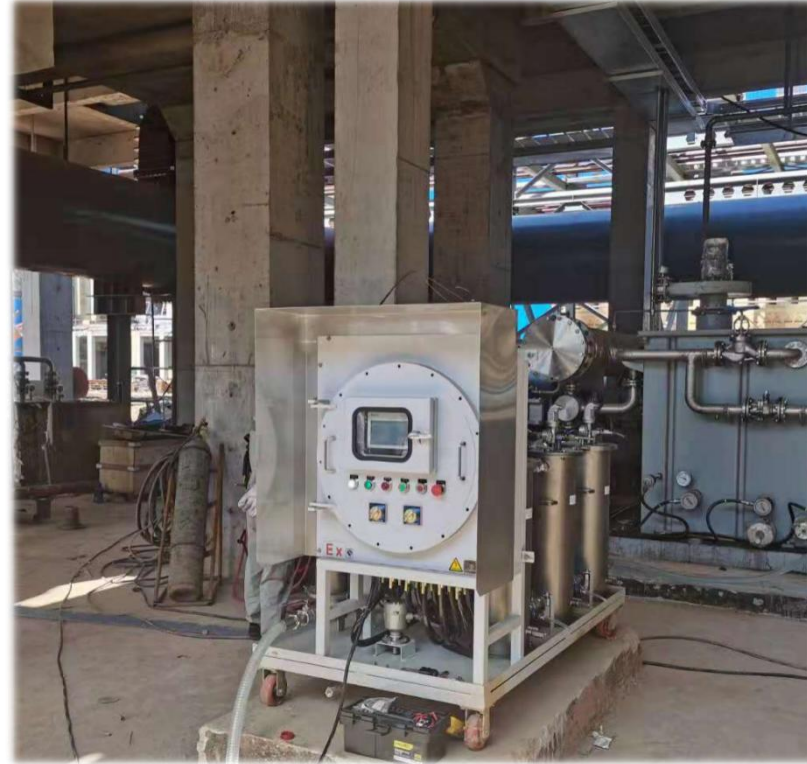
Device name: Shaanxi drum compressor

Wjj-50 oil purifier use time: From June 2021 to now, Cleanliness before purification NAS1638:11 (45 days) , Cleanliness after purification

NAS1638:6

▲ Device installation diagram

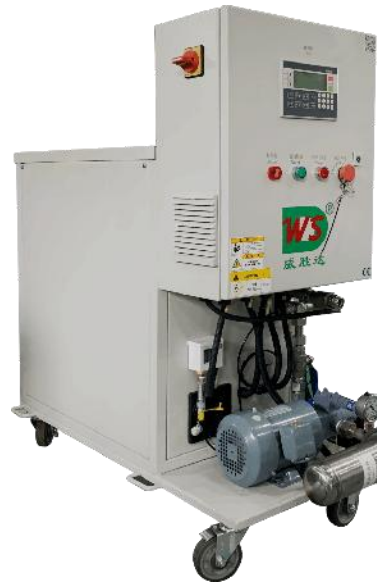
static electricity oil purifier

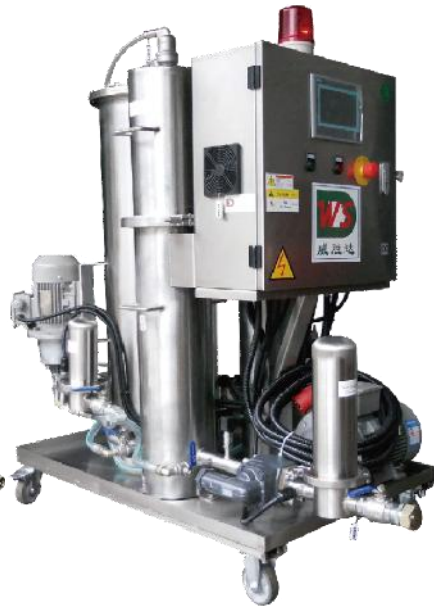
Balanced charge oil purifier

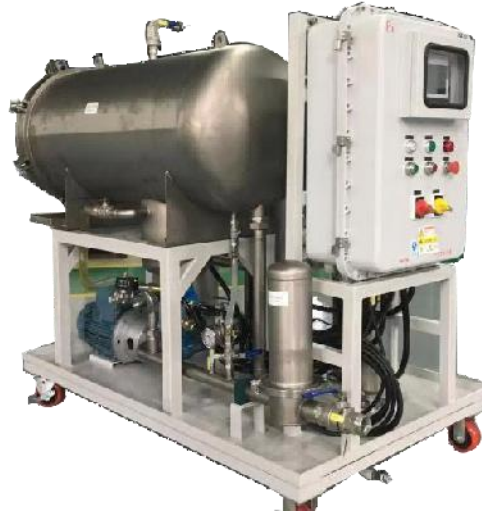
Coalescing and separating oil purifier

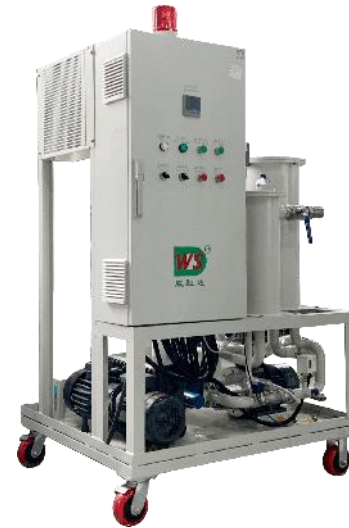
Vacuum water and oil purifier

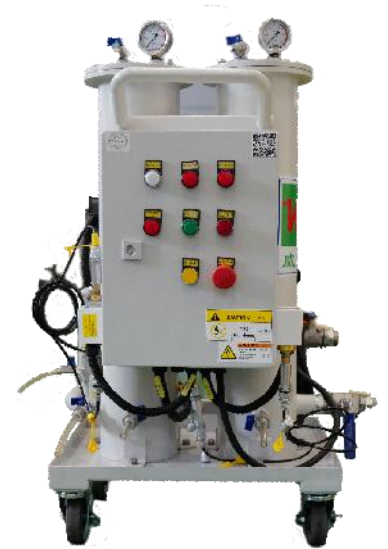
Refueling & filter trolley
